**FINAL REPORT  
ROUND 10 DAM ASSESSMENT  
PPL GENERATION, LLC.  
BRUNNER ISLAND POWER STATION  
ASH BASIN NO. 6 WITH POLISHING POND, EQUALIZATION POND AND  
INCIDENTAL WASTE TREATMENT BASIN (IWTB)  
YORK HAVEN, PENNSYLVANIA**

**DECEMBER 20, 2012**

**GZA GeoEnvironmental, Inc.  
One Edgewater Drive  
Norwood, Ma 02062  
GZA File No. 01.0170142.30**

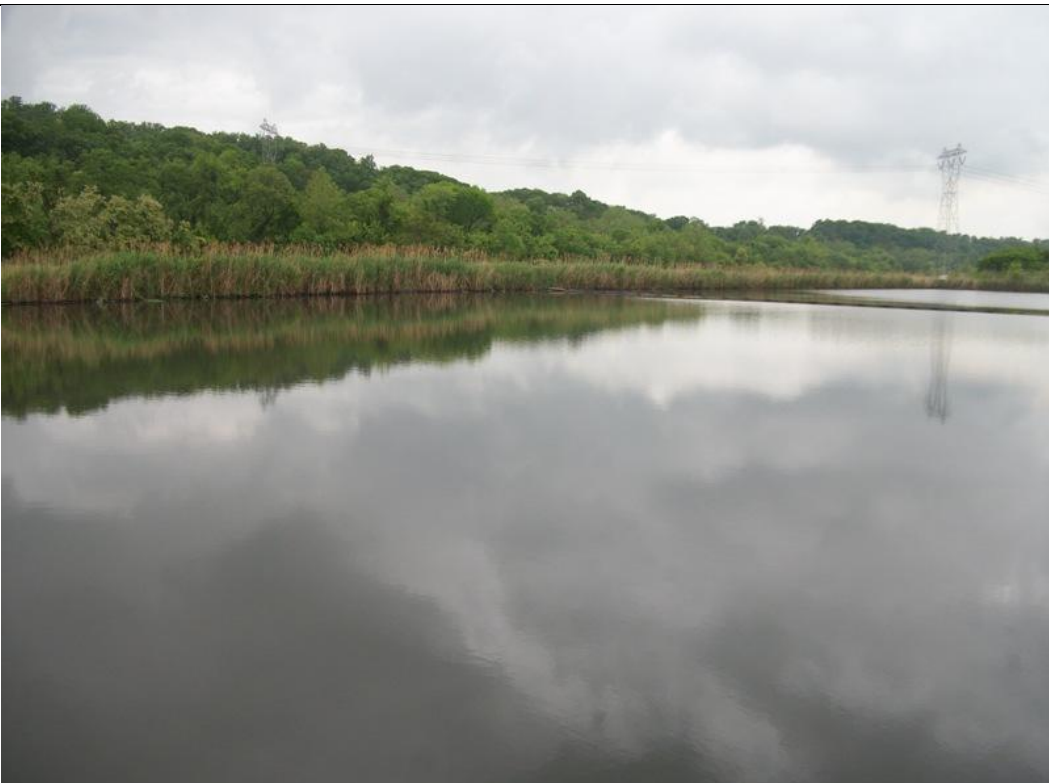
<b>Direction Photo Taken:</b> Westerly				
<b>Description:</b> Overview of west side of Ash Basin No. 6 as viewed from the decant intake structure. Note high vegetation/reeds along inside slope of basin.

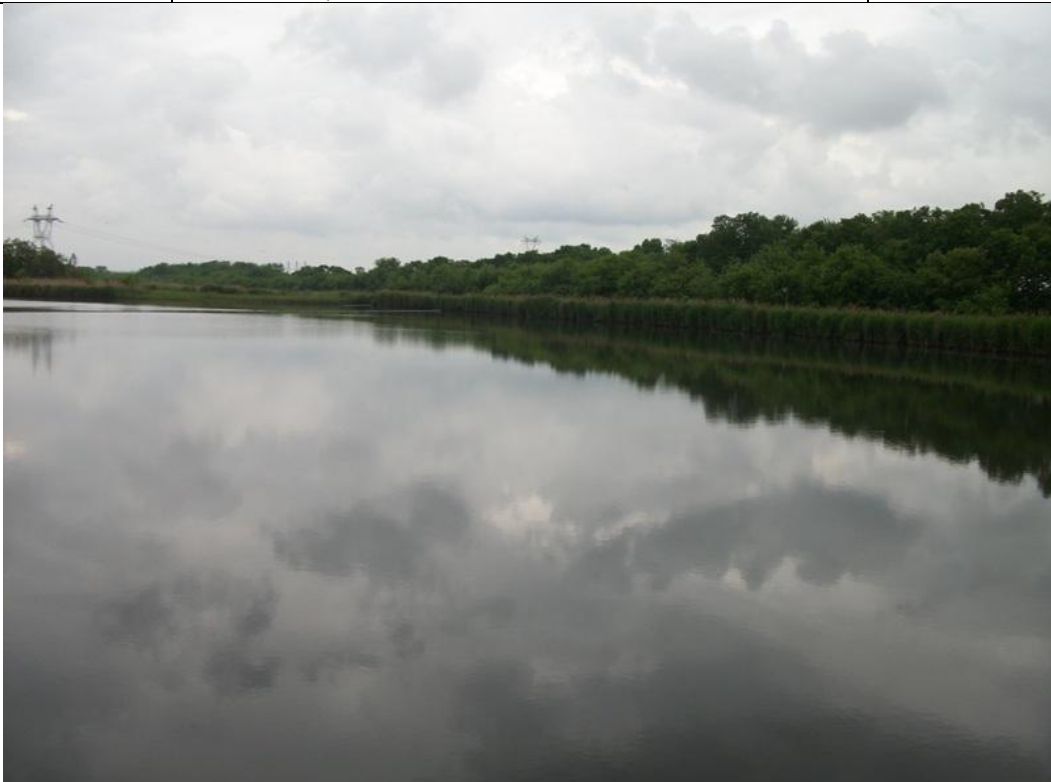
<b>Client Name:</b> U.S. Environmental Protection Agency		<b>Site Location:</b> PPL Brunner Island Station Ash Basin No. 6, York Haven, PA	<b>Project No.</b> 170142.30
<b>Photo No.</b> 3	<b>Date:</b> 5/18/2011

<b>Direction Photo Taken:</b> Northerly			
<b>Description:</b> Overview of east side of Ash Basin No. 6 as viewed from the decant intake structure. Note high vegetation/reeds along inside slope of basin.

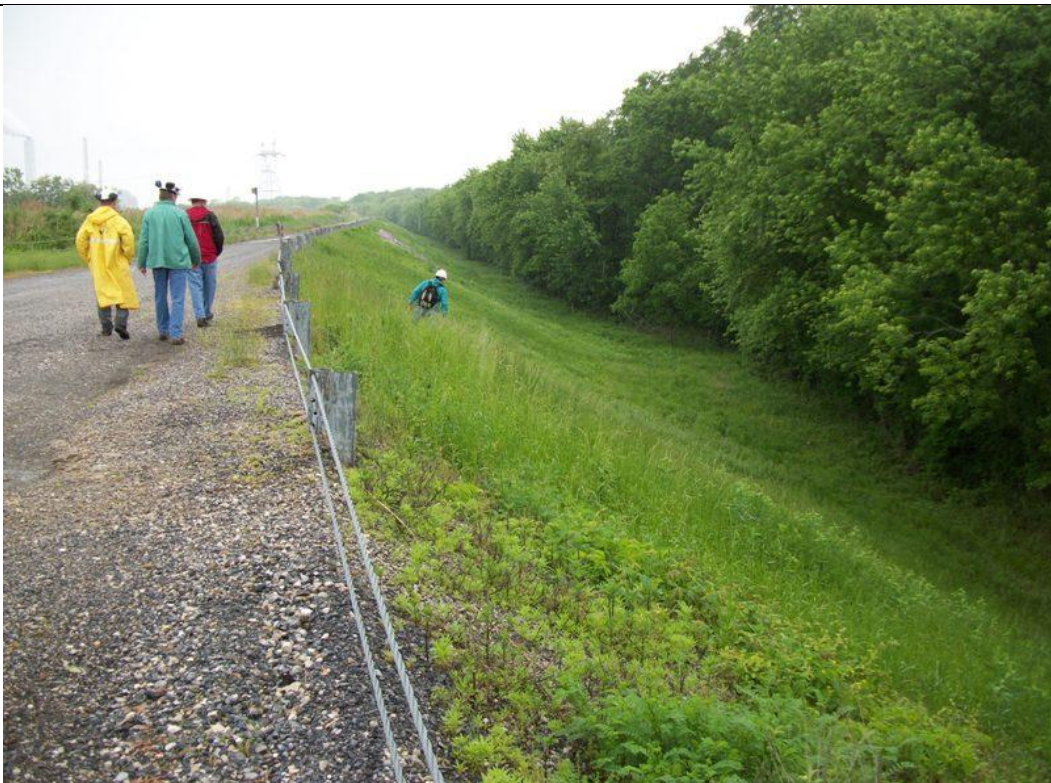
The East embankment generally appeared to be in fair condition. Grass and vegetation was overgrown at the outside slope and was approximately 12 to 36 inches in height (Photos 6 & 12). Standing water was observed at the toe, however heavy rains from the week prior to the inspection and recently high river levels from the Susquehanna may have contributed to the conditions at the toe (Photo 13). An approximately 40 foot wide spongy/soft area of ground was noted at the southern portion near the Polishing Pond to approximately 1/3 up the embankment, no movement was noted. A scarp was observed at the downstream toe approximately 75 feet south of the stairs from the crest (Photo 14).

<b>Direction Photo Taken:</b> Northerly			
<b>Description:</b> Outside slope of Ash Basin No. 6 east side embankment taken from the southeast corner of the basin.

1. Maintain grass cover on the downstream slope and approximately 15 feet beyond the toe area. USACE recommends vegetation be kept less than 12 inches in height on embankments. This may required mowing more frequently than bi-annually.
2. Fill ruts, depressions, and animal burrows and reseed if necessary.
3. Monitor and repair sloughing at the inside slope at the Polishing Pond and outside slope at the east embankment, or other locations sloughing is observed.
4. Exercise stoplogs and slide gates at least once annually.

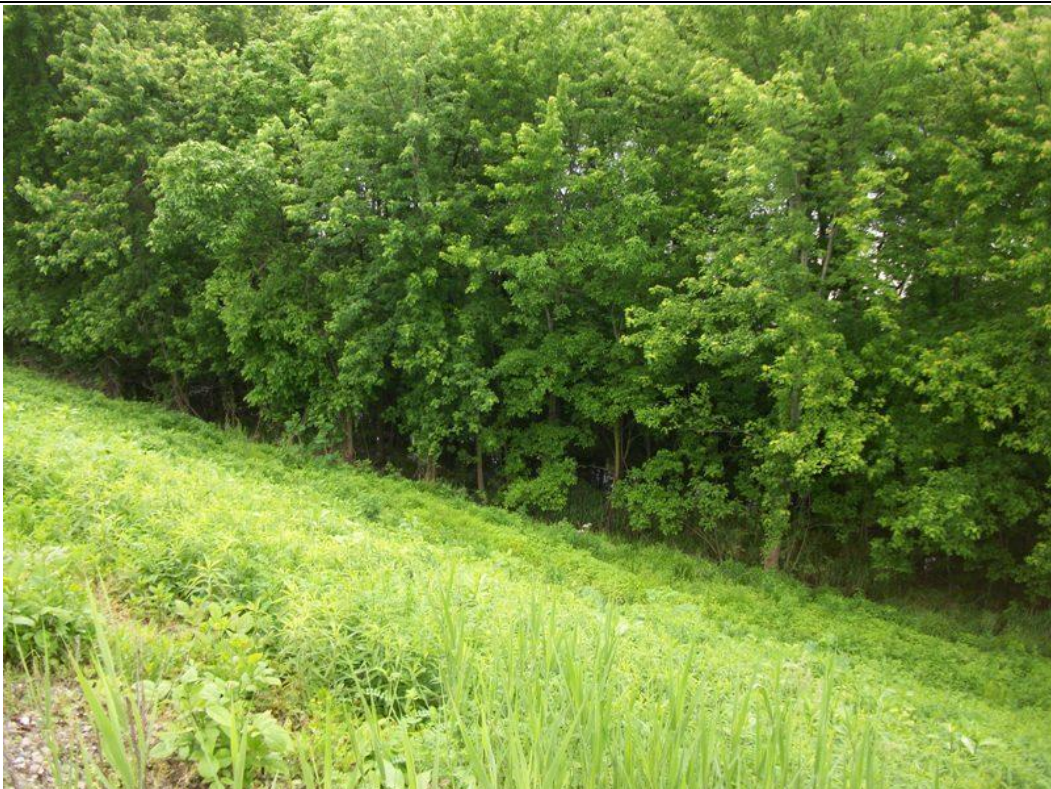
<b>Direction Photo Taken:</b> Northeasterly			
<b>Description:</b> Outside slope along east side embankment near southeastern end. Heavy tree/forest growth abuts toe of embankment along the majority of the east side. Note water through/beyond the trees is the Susquehanna River.

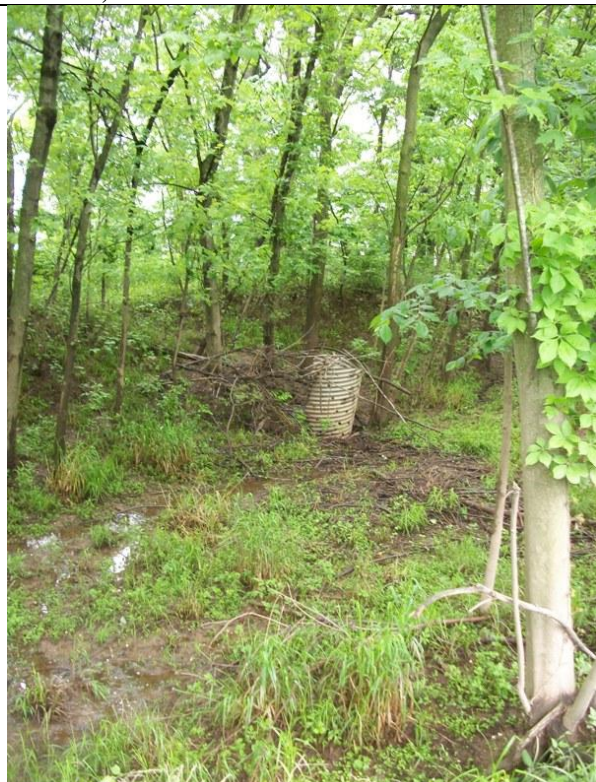
<b>Client Name:</b> U.S. Environmental Protection Agency		<b>Site Location:</b> PPL Brunner Island Station Ash Basin No. 6, York Haven, PA	<b>Project No.</b> 170142.30
<b>Photo No.</b> 15	<b>Date:</b> 5/18/2011

<b>Direction Photo Taken:</b> Southeasterly			
<b>Description:</b> Perforated CMP near in the area between the toe and the Susquehanna River at approximately the mid-point of the east side embankment. According to review of the design drawings, the pipe appears to be remnants of a temporary sedimentation pond associated with Ash Basin No's 6 original (circa 1978) construction.

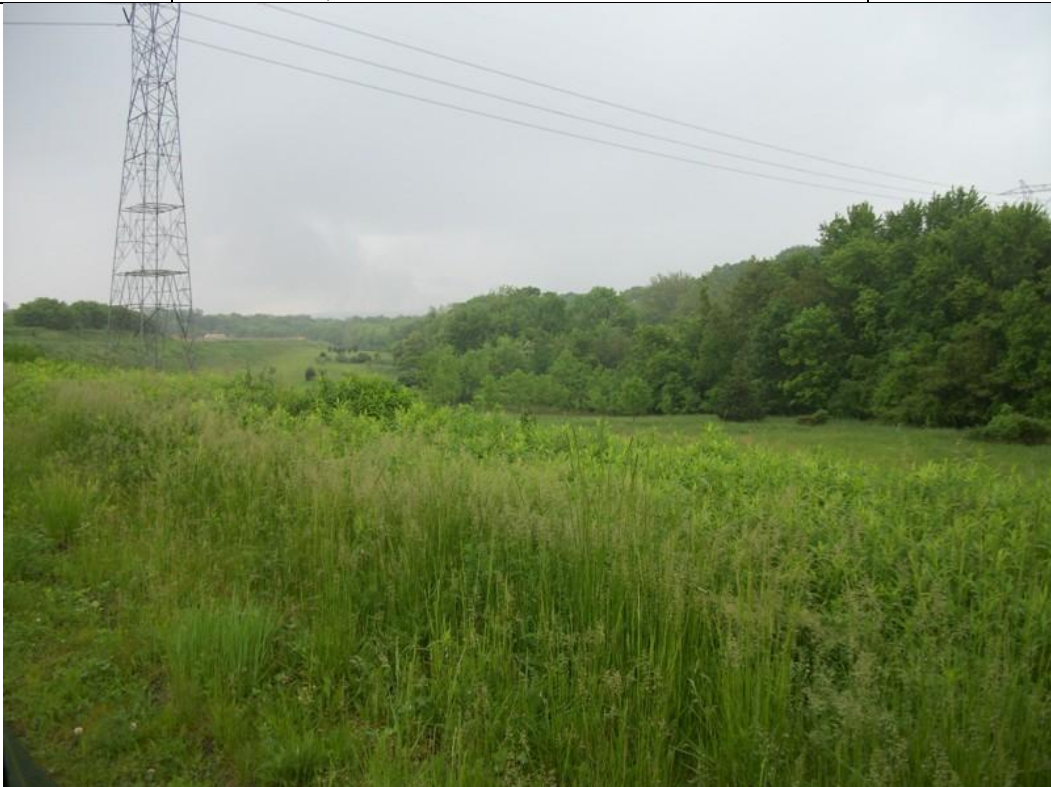
<b>Client Name:</b> U.S. Environmental Protection Agency		<b>Site Location:</b> PPL Brunner Island Station Ash Basin No. 6, York Haven, PA	<b>Project No.</b> 170142.30
<b>Photo No.</b> 20	<b>Date:</b> 5/18/2011

<b>Direction Photo Taken:</b> Southerly			
<b>Description:</b> View of outside slope and toe area beyond along the west side of Ash Basin No. 6 near the north end looking south. Note high vegetation particularly on slope. Annual mowing normally occurs in June.

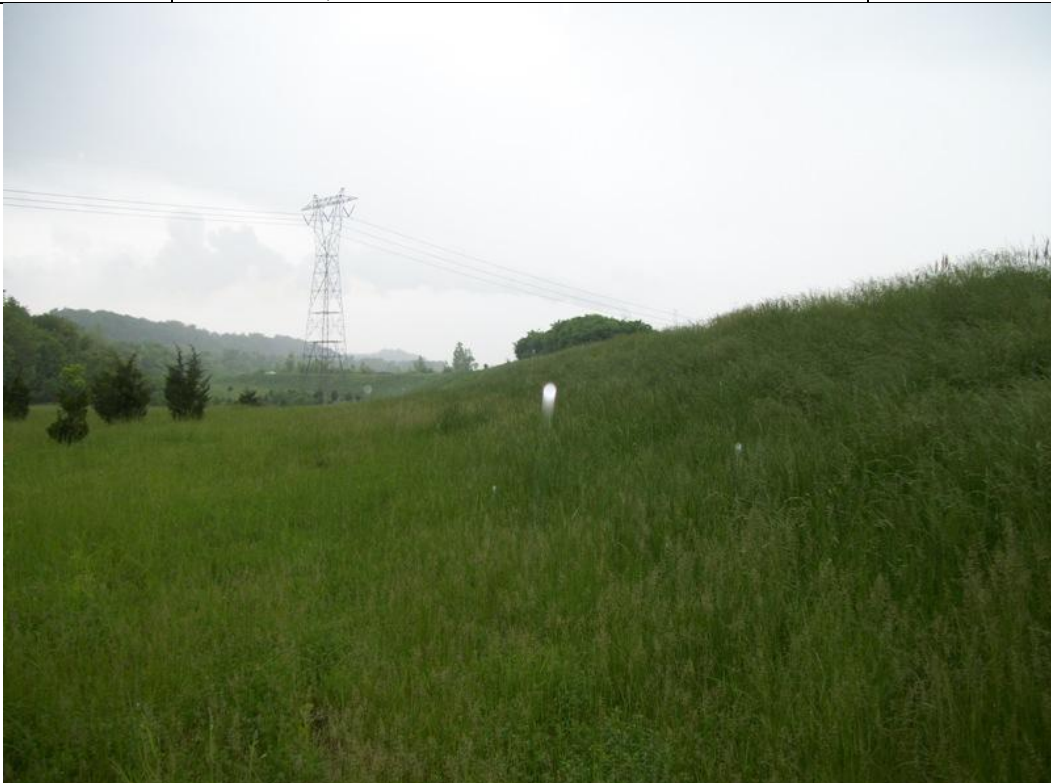
<b>Client Name:</b> U.S. Environmental Protection Agency		<b>Site Location:</b> PPL Brunner Island Station Ash Basin No. 6, York Haven, PA	<b>Project No.</b> 170142.30
<b>Photo No.</b> 22	<b>Date:</b> 5/18/2011

<b>Direction Photo Taken:</b> Northwesterly			
<b>Description:</b> Close-up view of west side embankment looking north. Note knee-high vegetation precluded close visual inspection. Annual mowing occurs in June.

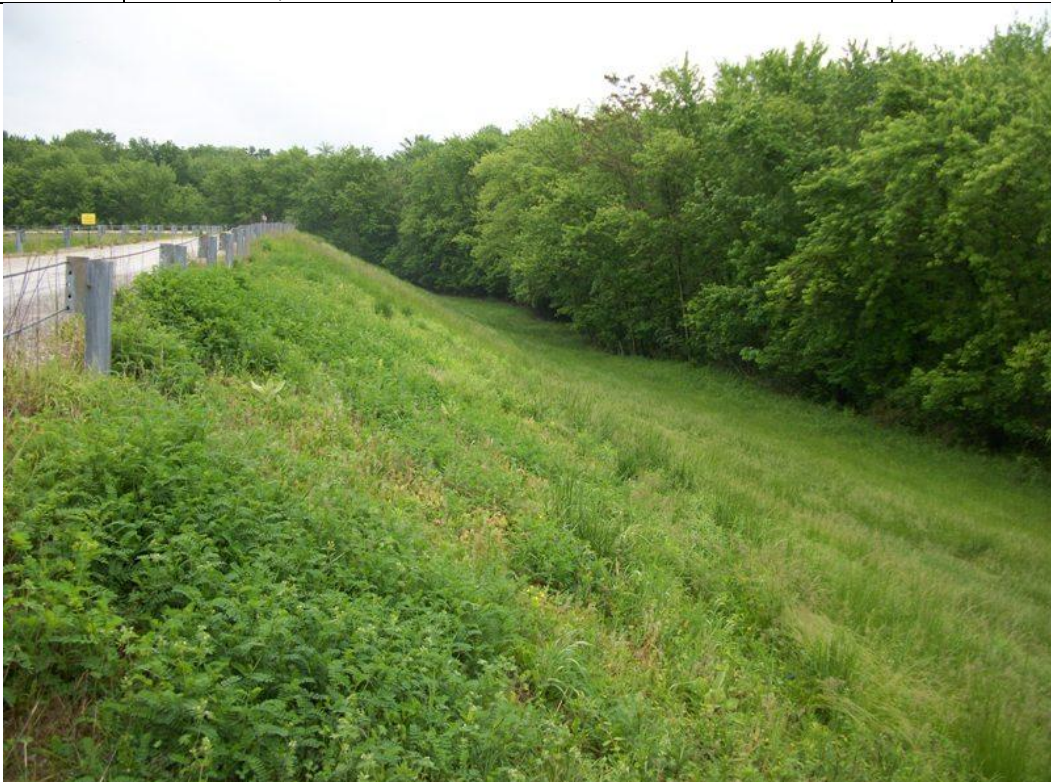
<b>Client Name:</b> U.S. Environmental Protection Agency		<b>Site Location:</b> PPL Brunner Island Station (Ah Basin No. 6) Polishing Pond, York Haven, PA	<b>Project No.</b> 170142.30
<b>Photo No.</b> 29	<b>Date:</b> 5/18/2011

<b>Direction Photo Taken:</b> Southerly			
<b>Description:</b> Outside slope along west embankment. Note knee-high vegetation precluded close visual inspection. Annual mowing occurs in June.

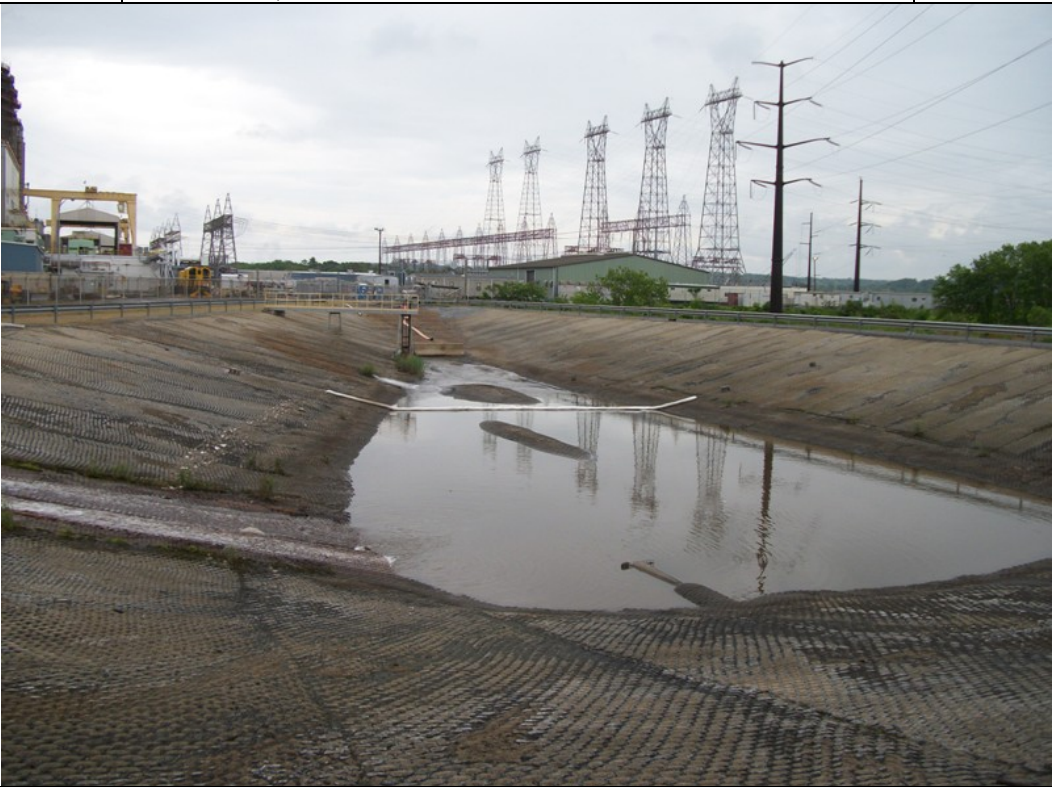
<b>Direction Photo Taken:</b> Northerly			
<b>Description:</b> Overview of the Equalization Basin from the southern end. Note concrete erosion control revetment matting along inside slopes.			
<b>Photo No.</b> 36	<b>Date:</b> 5/18/2011

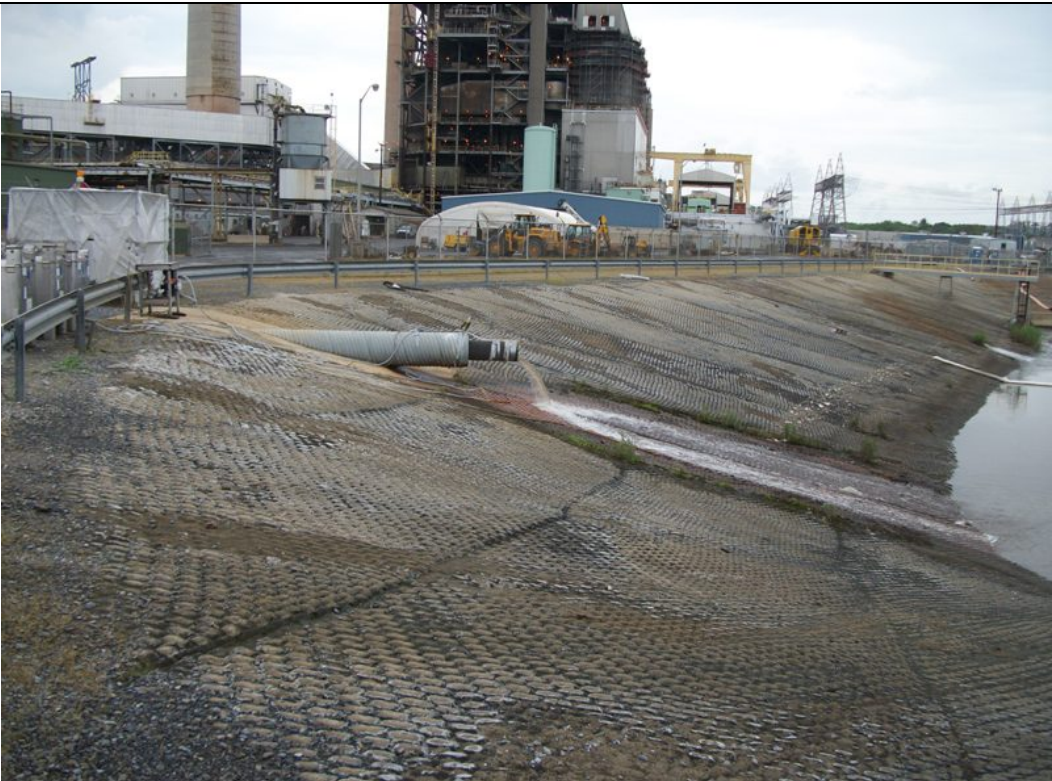
<b>Direction Photo Taken:</b> Northwesterly			
<b>Description:</b> View of west inside slope depicting incised nature of construction. Note discharge pipe from plant storm water runoff.

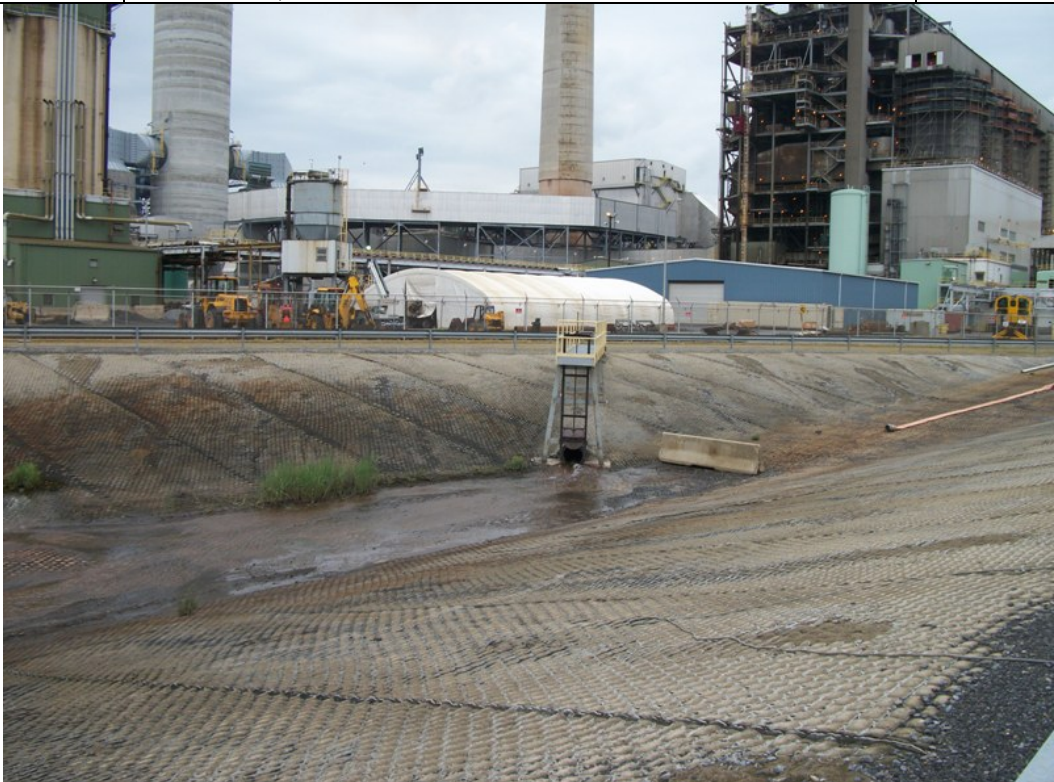
<b>Direction Photo Taken:</b> Westerly			
<b>Description:</b> North end of equalization Basin. Note slide gate and 24-inch-diameter pipe. Pipe conveys discharge of a portion of the Plant's interior drainage collection system.

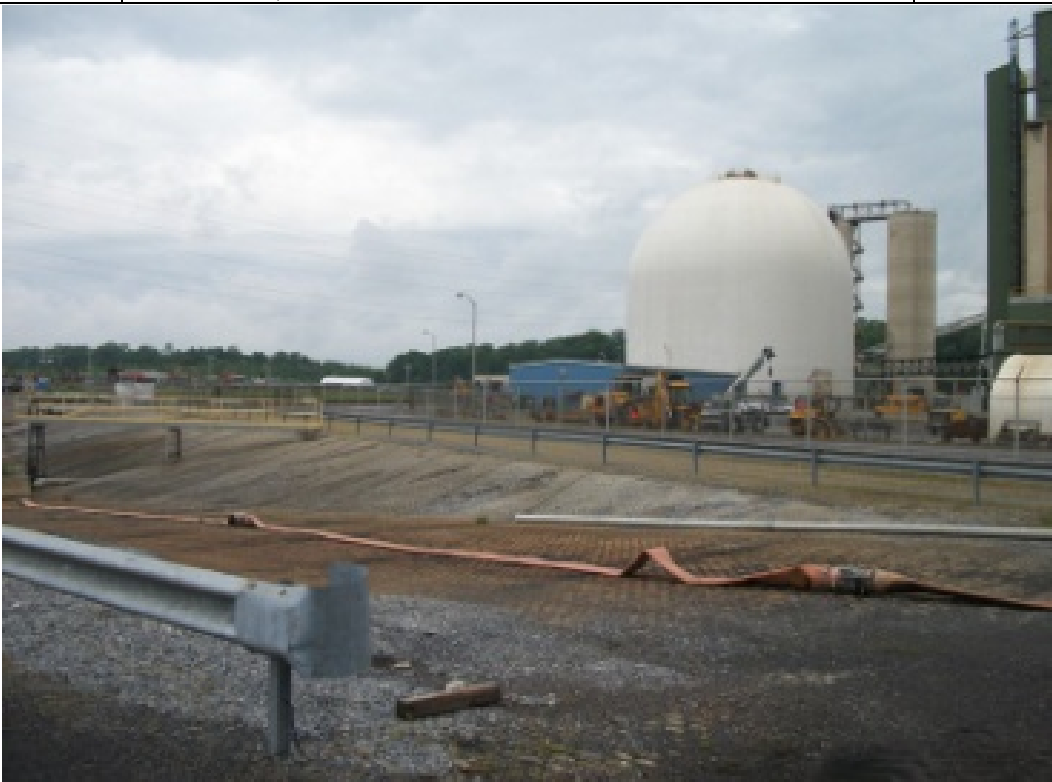
<b>Direction Photo Taken:</b> Southerly			
<b>Description:</b> View of northern end of the Equalization Basin.

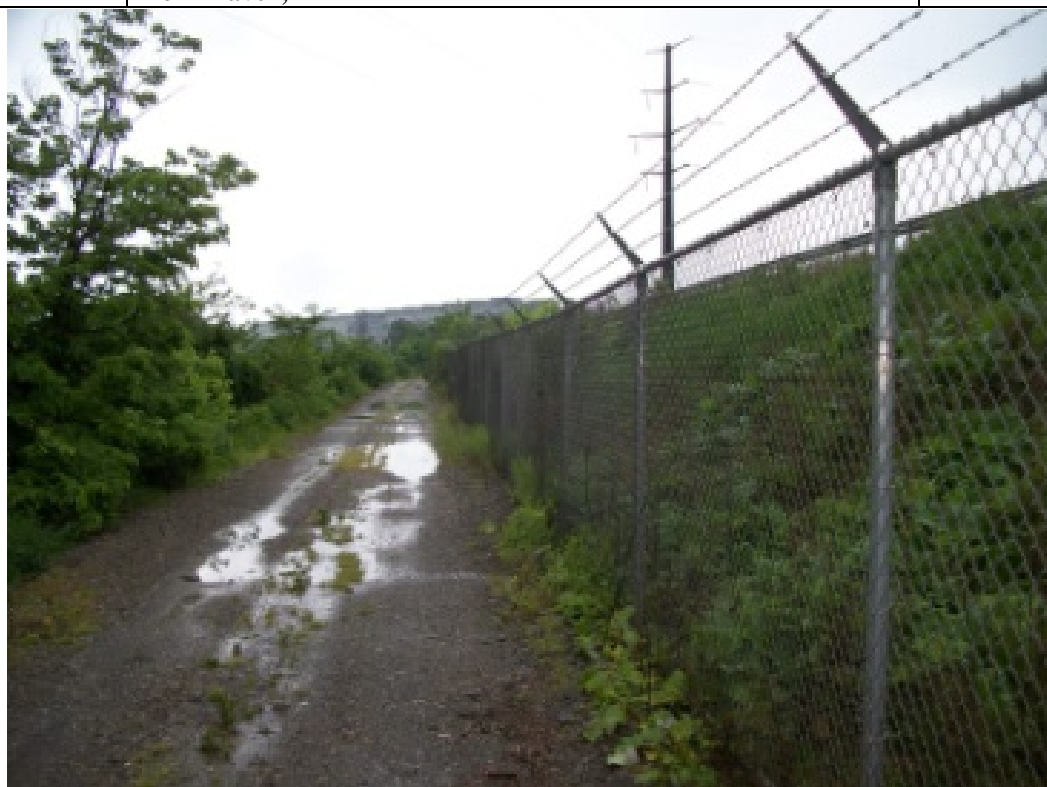
Toe of eastern embankment  
slope as viewed from the  
north. Access road area  
immediately beyond toe.

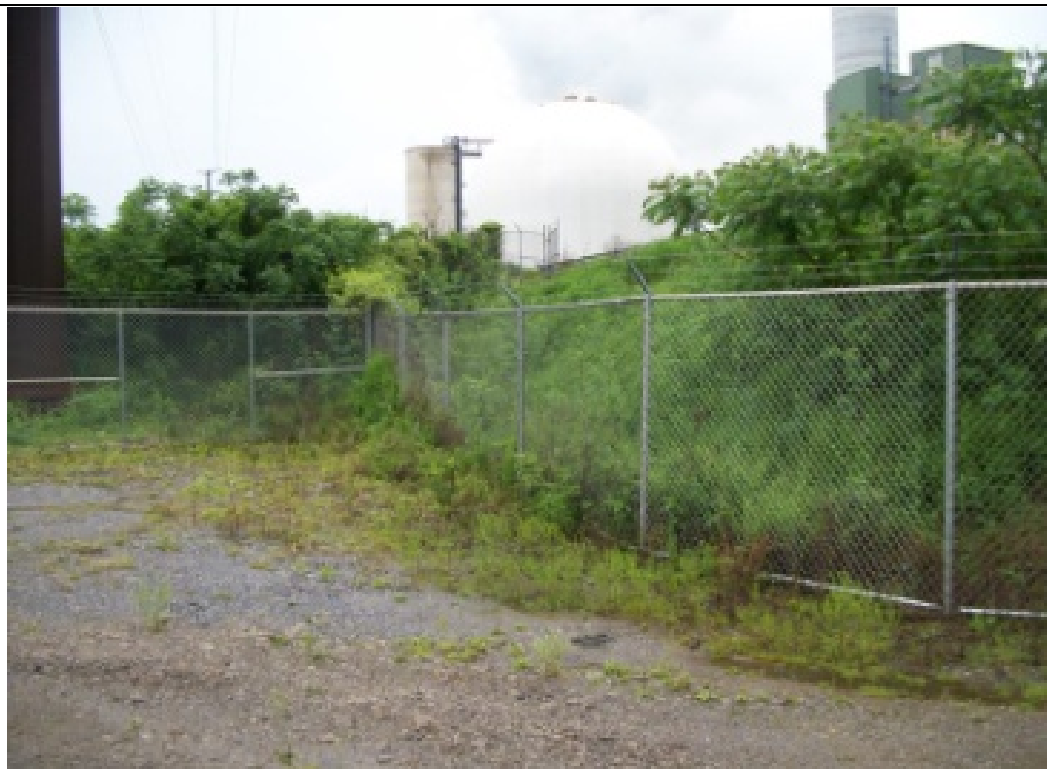
Toe of southern embankment  
slope looking west.

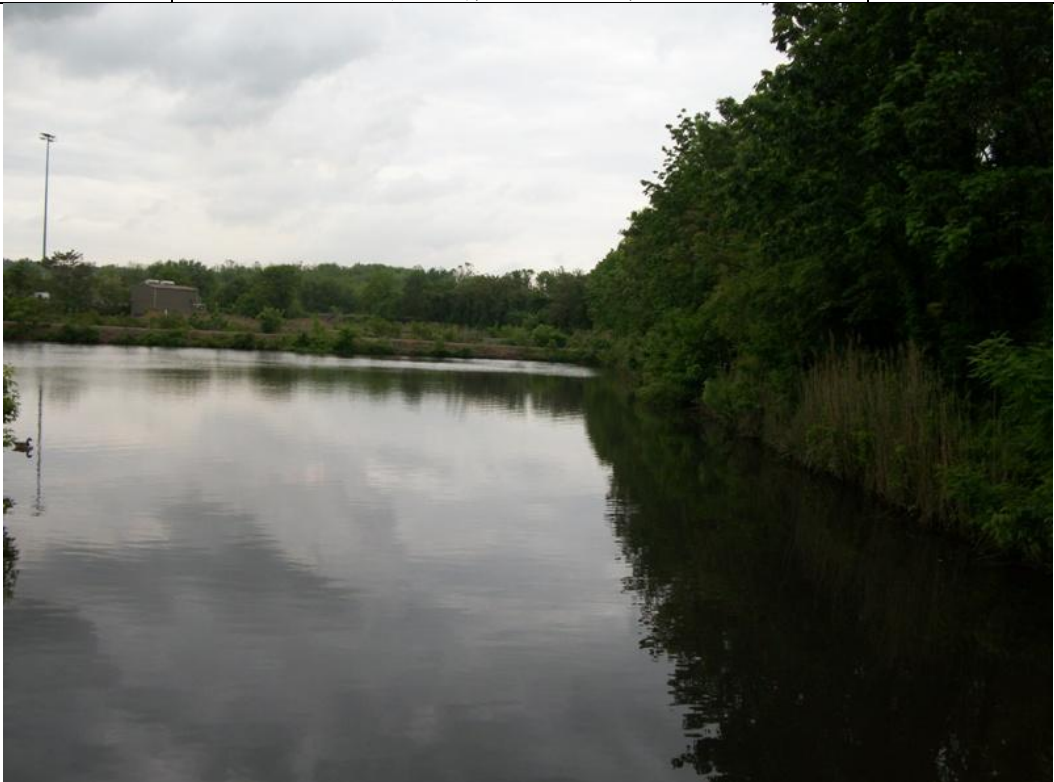
<b>Direction Photo Taken:</b> Northwesterly			
<b>Description:</b> Overview of the south lagoon from the Decant Gate and Sensor Equipment Monitoring Structure. Note north side of north lagoon as well as the east sides of the north, middle and south lagoons are bordered by the Susquehanna Flood Control Levee, the top of which is approximately 11 feet higher than the incised IWTB lagoons.

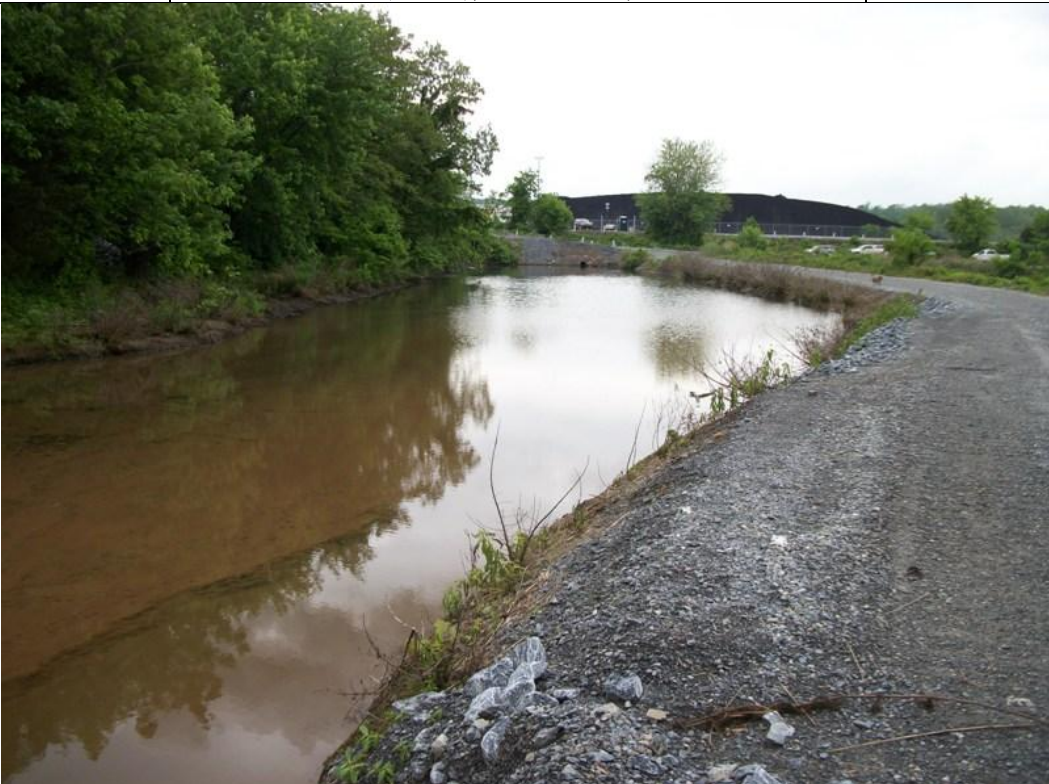
<b>Direction Photo Taken:</b> Southwesterly			
<b>Description:</b> Intake Water Treatment Plant solids settling basin situated at the southern most portion of the IWTB. Note water flows to the canal which runs along the west side of the IWTB to the Coal Pile Runoff Treatment Facility.			
<b>Photo No.</b> 48	<b>Date:</b> 5/18/2011

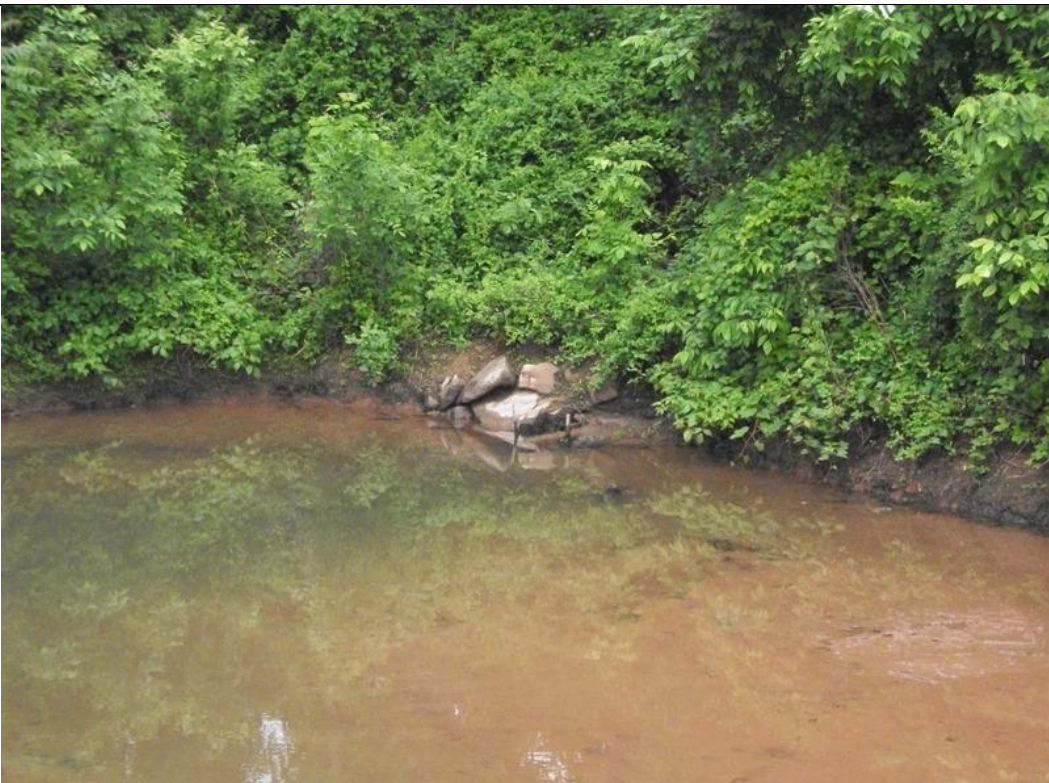
<b>Direction Photo Taken:</b> Southerly			
<b>Description:</b> Stone protection over CMP discharge pipe at eastern end of Intake Water Treatment Plant solids settling basin. Flow through pipe is discharge from the Intake Water Treatment Plant which is located approximately 650 feet southeast of this location.

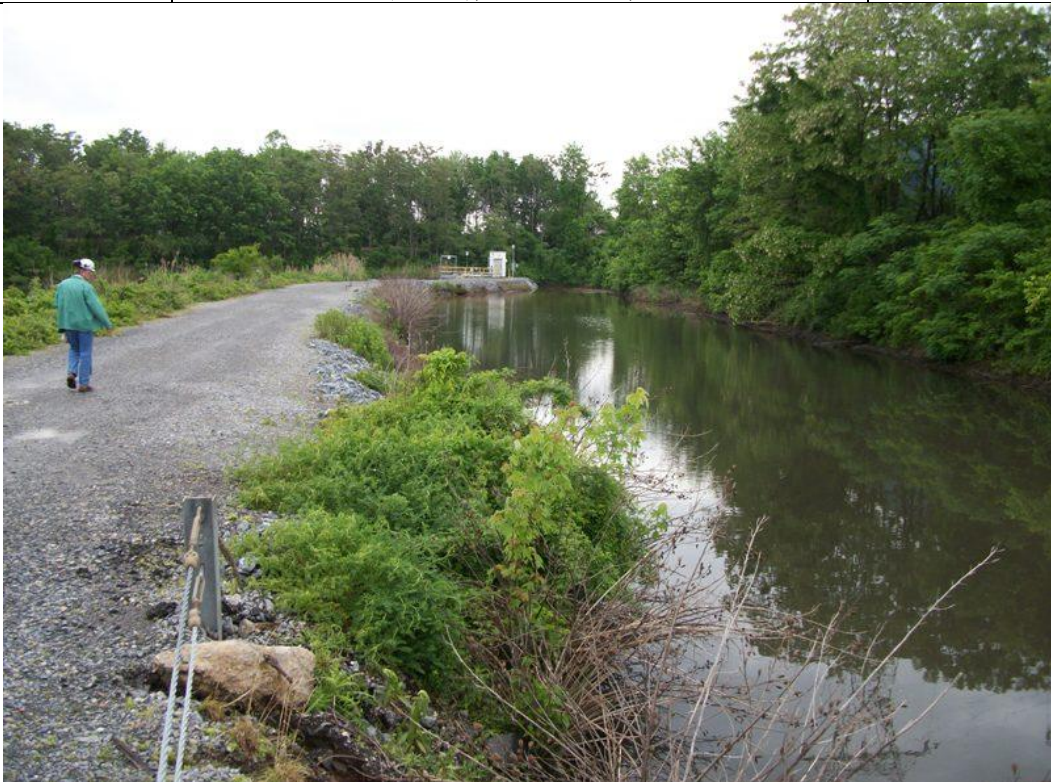
<b>Direction Photo Taken:</b> Easterly			
<b>Description:</b> Intake Water Treatment Plant solids settling basin viewed from the west end. Note common dike separating the basin and south lagoon (left).

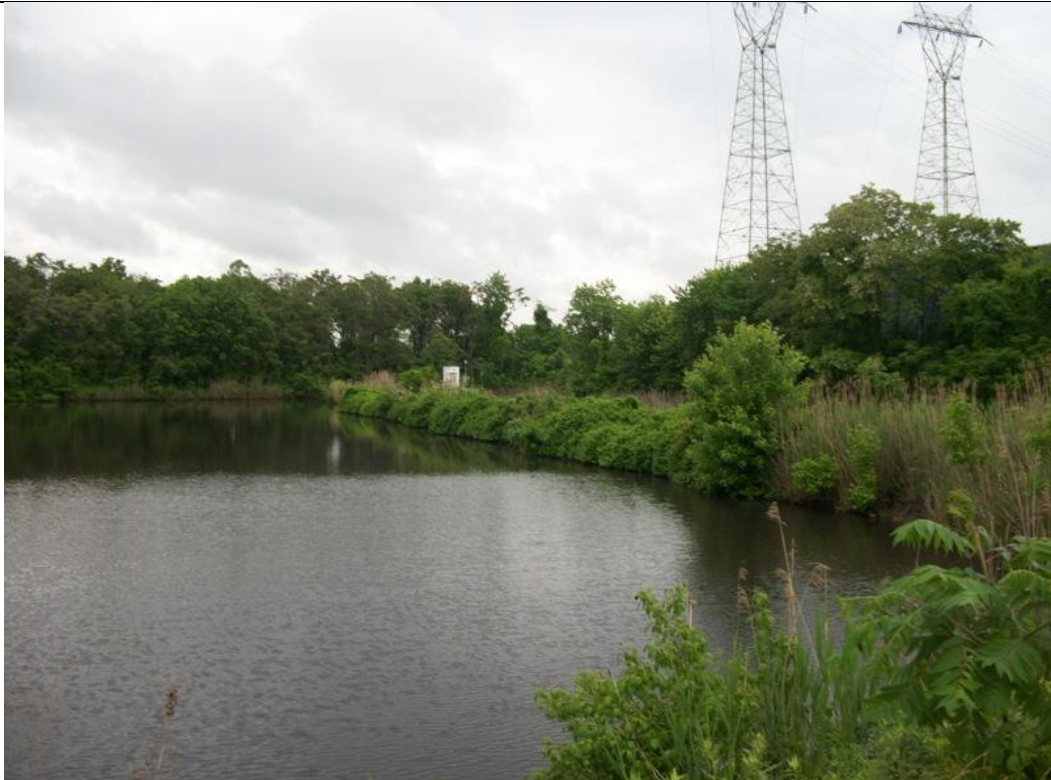
<b>Photo No.</b> 50	<b>Date:</b> 5/18/2011

<b>Direction Photo Taken:</b> Easterly		
<b>Description:</b> View of inside slope of south side dike at the south lagoon. Note heavy vegetation and shrubbery precluded close visual inspection of slope.

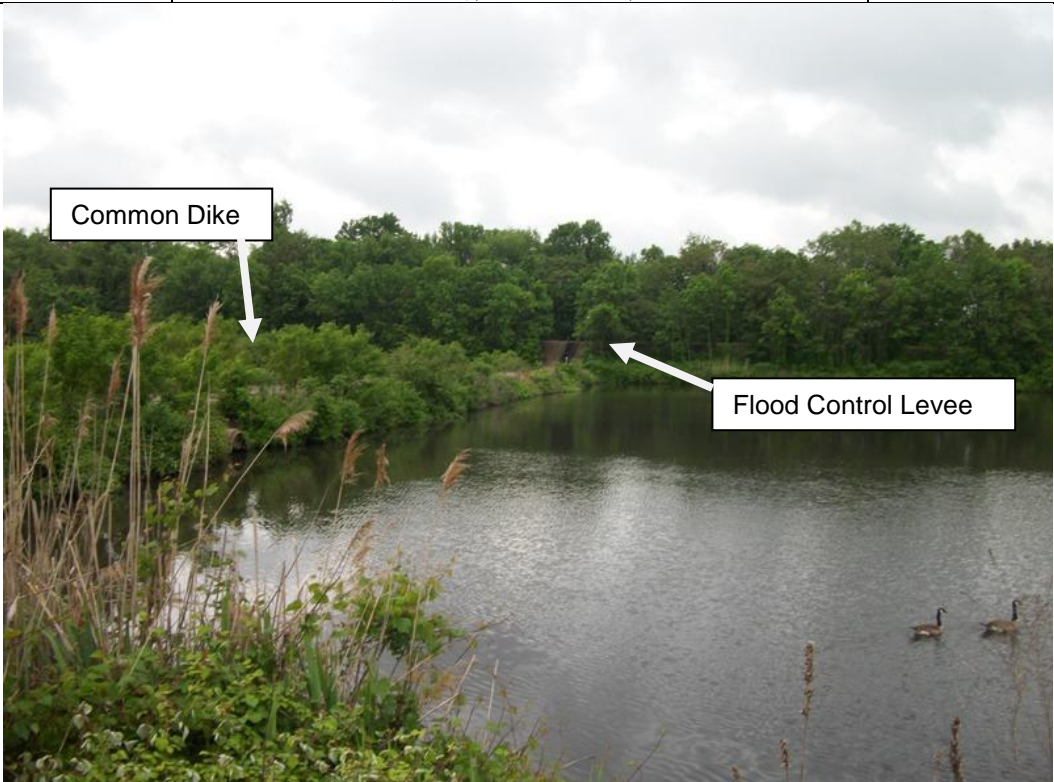
<p>Common Dike</p> <p>Flood Control Levee</p>	
<b>Direction Photo Taken:</b> Northeasterly			
<b>Description:</b> (At left) view of inside slope of common dike between the middle and south lagoons. Note heavy shrub/small tree growth and high vegetation. Also note the higher elevation Susquehanna Flood Control Levee in the background which forms the east side of the north, middle and south lagoons.

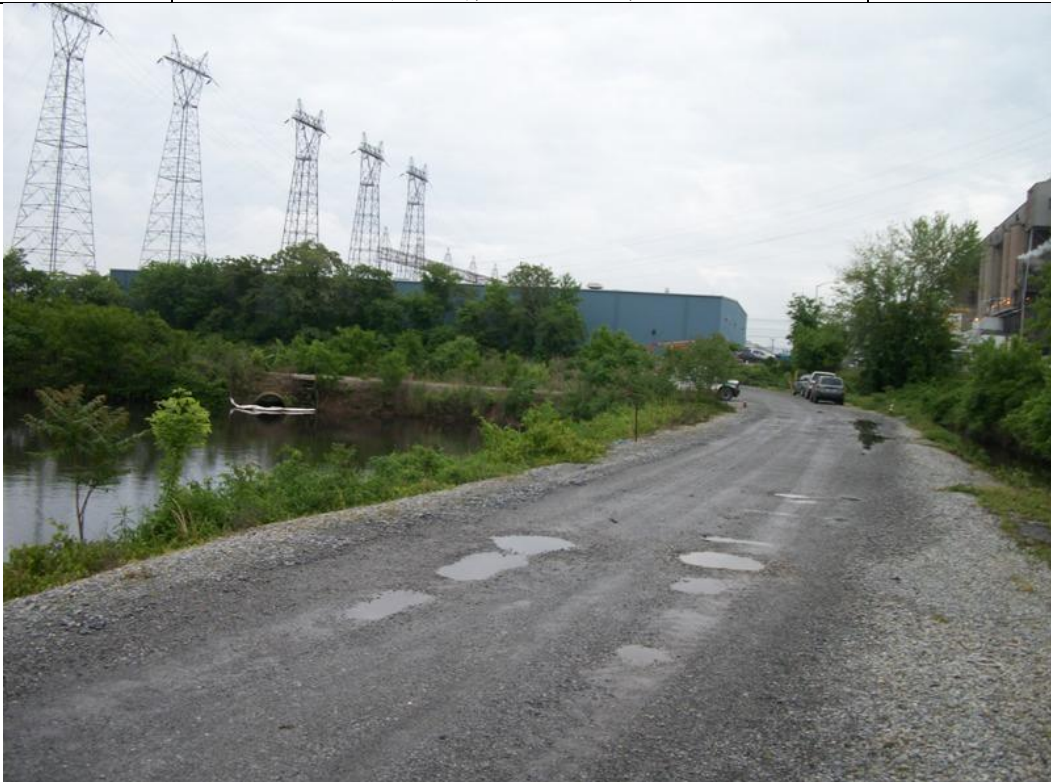
<b>Direction Photo Taken:</b> Southeasterly			
<b>Description:</b> Travel way dike along western side of IWTB. Canal along right side of travel way conveys water to the Coal Pile Runoff Treatment Facility for eventual discharge into the north lagoon.

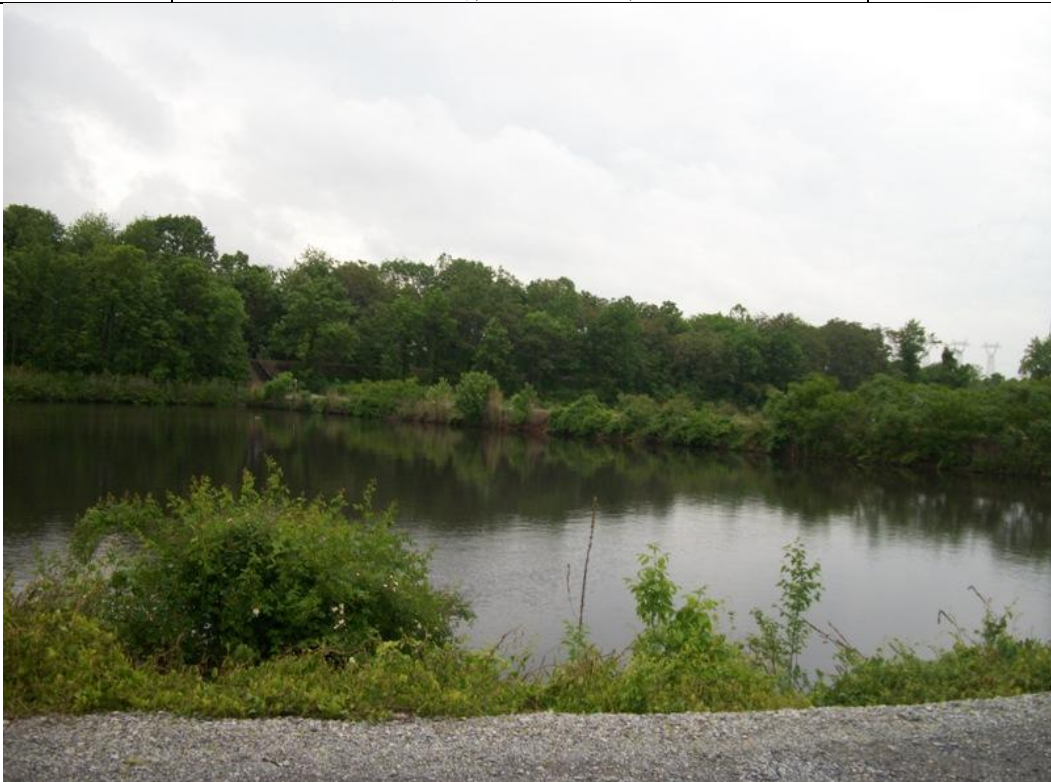
<b>Direction Photo Taken:</b> Easterly			
<b>Description:</b> Overview of middle lagoon from western end. Note moderate to heavy vegetation, shrubbery and small trees along inside slopes.

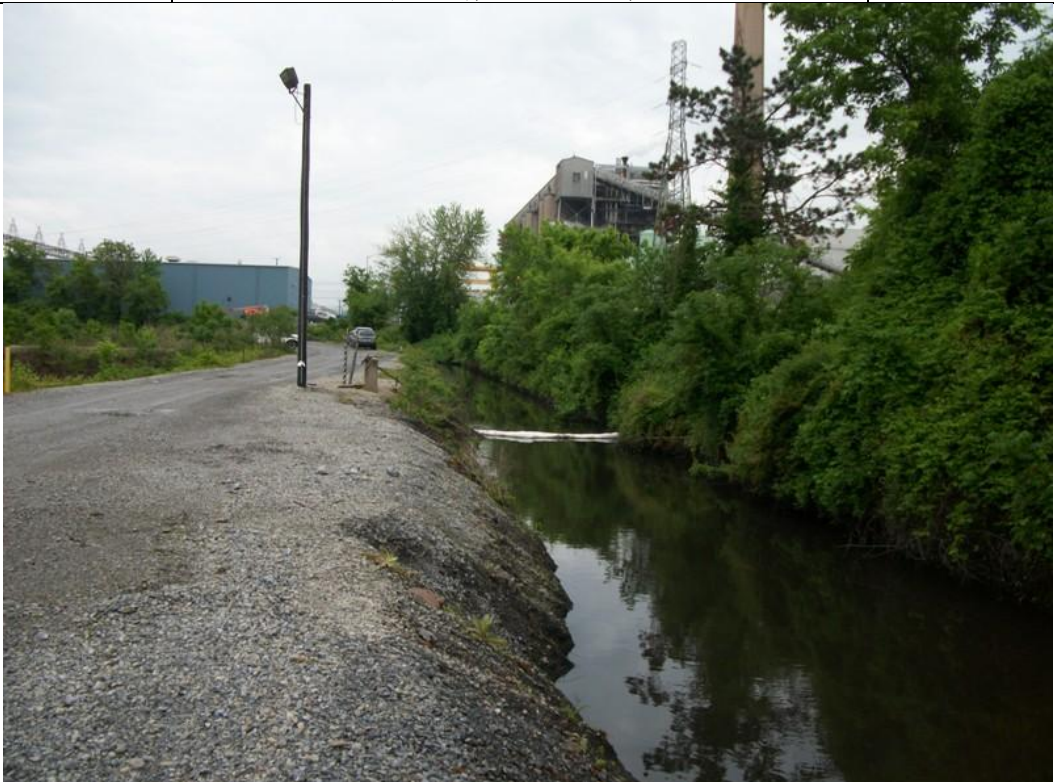
<b>Direction Photo Taken:</b> Southeasterly			
<b>Description:</b> Overview of canal along western side of IWTB looking southeasterly. Note minor to moderate erosion/scarps along slope.

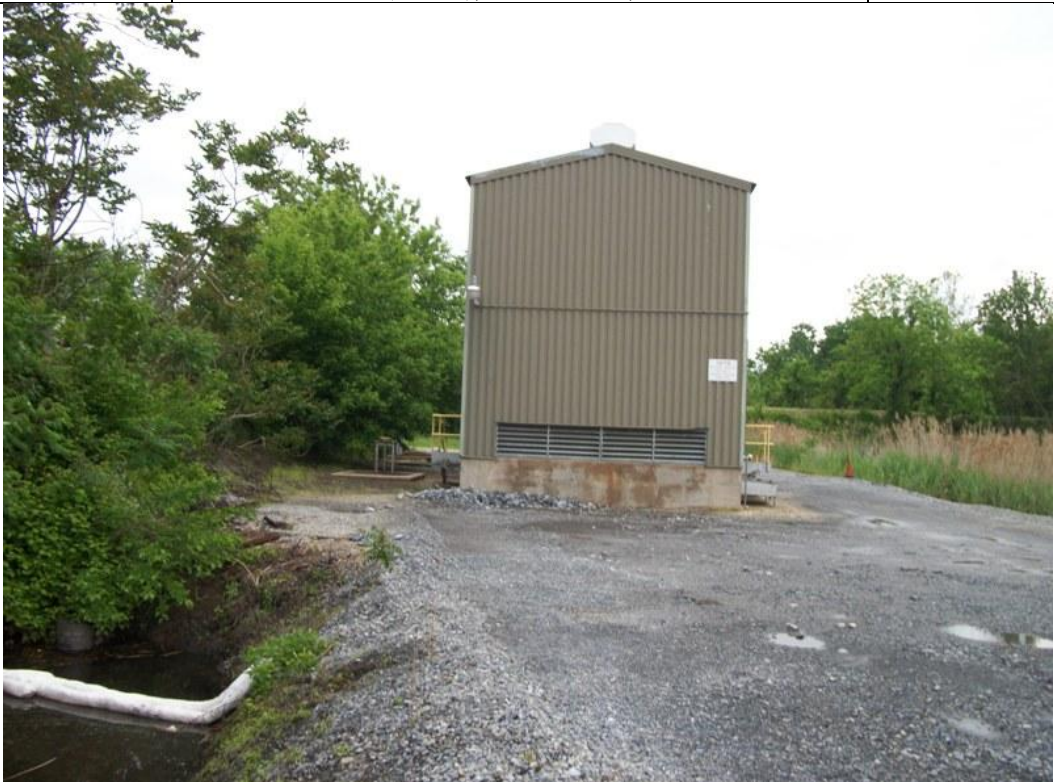
<b>Direction Photo Taken:</b> Northwesterly			
<b>Description:</b> View of Coal Pile Runoff Water Treatment Facility at northwestern portion of the IWTB. Note concrete intake from west side canal (lower left).

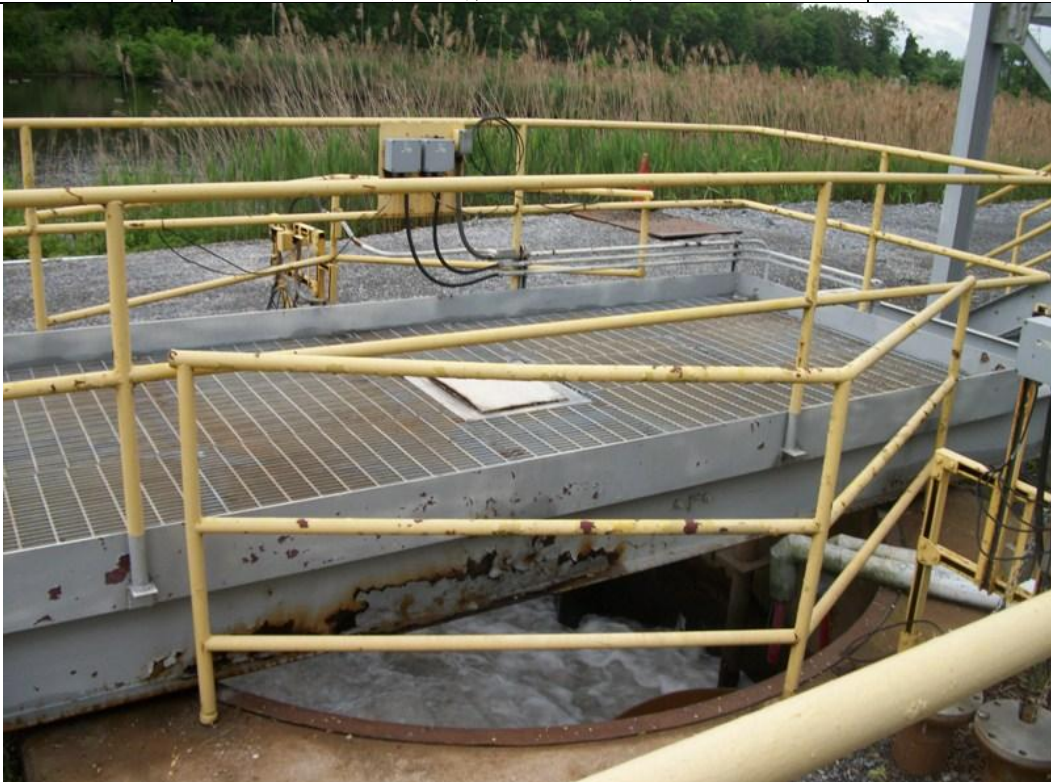
<b>Direction Photo Taken:</b> Easterly			
<b>Description:</b> Mixing tanks at Coal Pile Runoff Treatment Facility. Note water is discharged from the treatment facility to the north lagoon.			
<b>Photo No.</b> 62	<b>Date:</b> 5/18/2011
